# Manhole Inspection Summary

Manhole # S2100\_005MH

Insp Date: **12/16/08 2:01 PM**

**Location** Address: **2285 REISTERSTOWN RD**

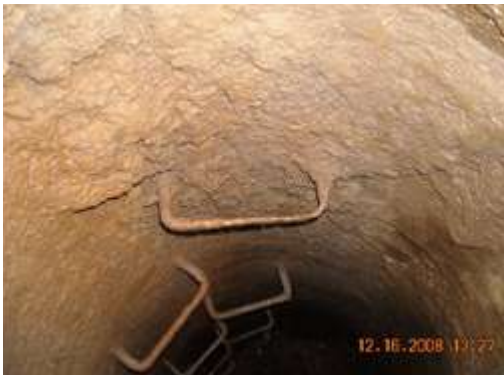
Defect 2

Count: **9** Missing: **0** ☒ **Corroded**

LOOKS LIKE WATER ENTERS MH AND CAUSING DEPOSITE ON WALLS AND CORRODED STEPS

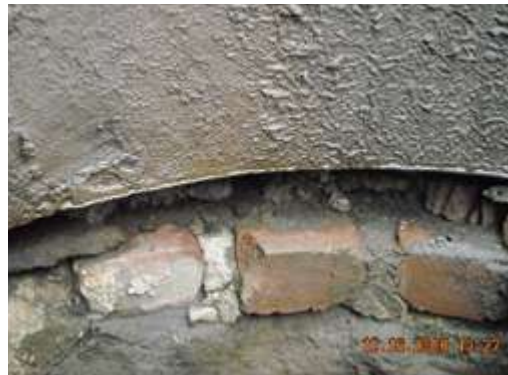
Defect 1

Condition: ☐ Sound ☐ Cracked ☐ Root Intrusion ☒ **Loose Brick** ☒ **Deteriorated**

Infiltration: ☐ None ☐ Joint ☐ Cracks ☐ Mortar ☐ Roots ☒ **Wall**

LOOSE AND MISSING BRICKS BELOW FRAME IN CHIMNEY

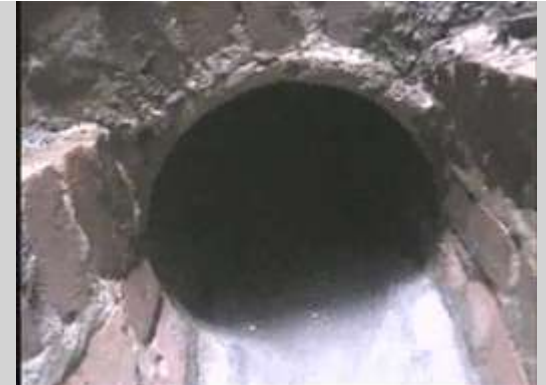
12 O'Clock Outflow

12 in. Circular Gravity Sewer  
Pipe Out @ 12 O'Clock

Pipe Height: **12** (in.) Rod and Bar (Angled)  
Pipe Material: **Clay** ☐ Pipe Lined  
Invert Depth: **13.90** (ft.) Flow Characteristics: **Slow**  
Deposits: ☒ None ☐ Mud ☐ Sludge ☐ Debris ☐ Grease  
Silt Depth: (in.) Deposits Extent:  
Infiltration: **None** Pipe Seal Cond: **Sound**

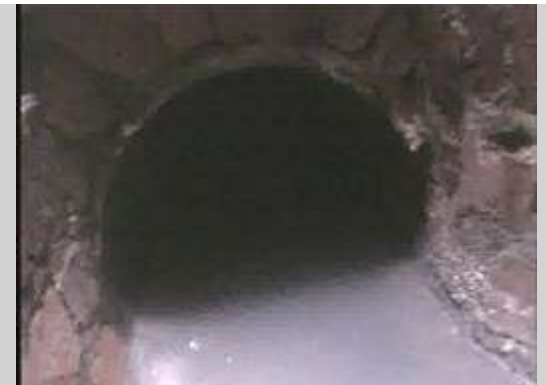
3 O'Clock Inflow

12 in. Circular Gravity Sewer  
Pipe In @ 3 O'Clock

Pipe Height: **12** (in.) Rod and Bar (Angled)  
Pipe Material: **Clay** ☐ Pipe Lined  
Invert Depth: **13.85** (ft.) Flow Characteristics: **Slow**  
Deposits: ☒ None ☐ Mud ☐ Sludge ☐ Debris ☐ Grease  
Silt Depth: (in.) Deposits Extent:  
Infiltration: **None** Pipe Seal Cond: **Sound**
